Hidden emissions: A story from the Netherlands

Case Study

November 2018 – ToxicoWatch

The youngest of Dutch incinerators: Reststoffen Energie Centrale

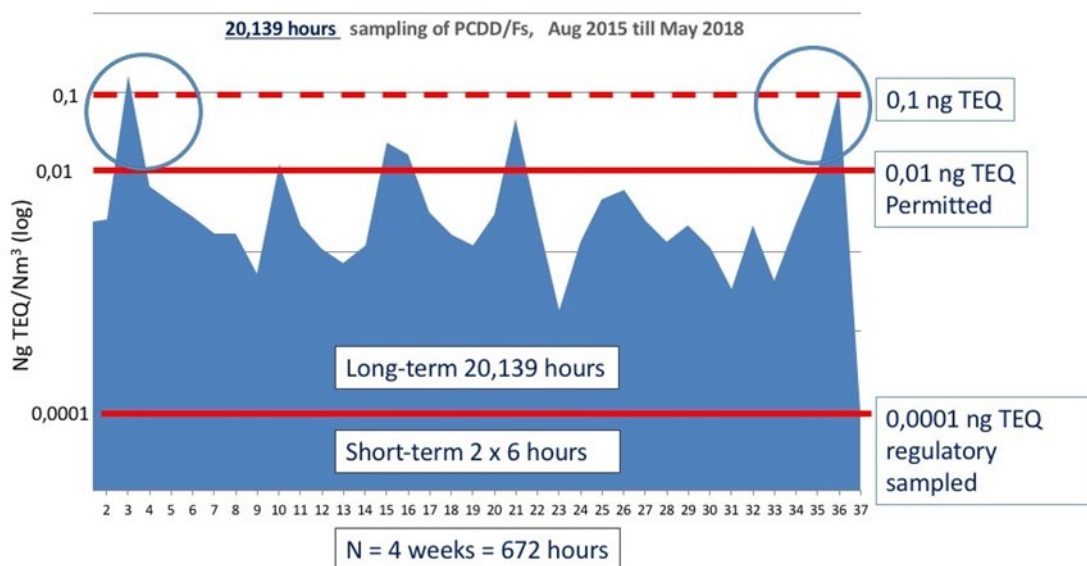
Figure 3: Results of 20,139 hours AMESA long-term sampling PCDD/Fs, REC Harlingen

Figure 3 shows the results of a **20,139** hours long-term sampling of dioxins (PCDD/Fs) from August 2015 until December 2017, revealing that excess emissions (“outlier events”) are not exceptional, but rather constitute a regular feature of the REC incineration operation. The results of long-term sampling clearly show the shortcomings of regulatory short-term measurements¹⁴.

Announced and presented as “State of the art” and applying with Best Available Techniques /Best Environmental Practices¹⁵, the REC incinerator has a very stringent emission limit of 0.01 ng TEQ/Nm³¹⁶. In Figure 3, a number of excursions above the legal threshold limit can be noted. The horizontal lines indicate from bottom to top the short-term measurements, emission limits set for the REC in the environmental permit, as well as in the permit by the Integrated Pollution Prevention and Control (which is now the IED, International Emission Directive¹⁷). A total number of 12 start-up and shutdown events occurred in the measuring period. The permitted limit of 0.01 ng TEQ/Nm³ was exceeded seven times, and the IED standard of 0.1 ng TEQ/Nm³ twice. As the exceeding of dioxin

Unfortunately, even AMESA cannot perform continuous sampling during transient phases. In all breaches of the permit emission limit (see Figure 3) the long-term sampling by the AMESA was found to be incomplete. During the first outlier event in Figure 3 (exceeding 0.1 ng TEQ/Nm³), the long-term sampling was interrupted for 10 hours, and for more than 200 hours during the last outlier event. During the 20,139 hours of long-term sampling of the REC incinerator, AMESA was off-line for 1,496 hours¹⁸. While AMESA is mostly on-line (93% of the time), dust emissions especially occur when AMESA is off-line. During start-ups the ID-fan (see Figure 4) is regularly turned off, which results in a shut down and a restart of the AMESA, suspending the test for 3 minutes. When this process is repeated, the long-term sampling will be disabled for a certain time.

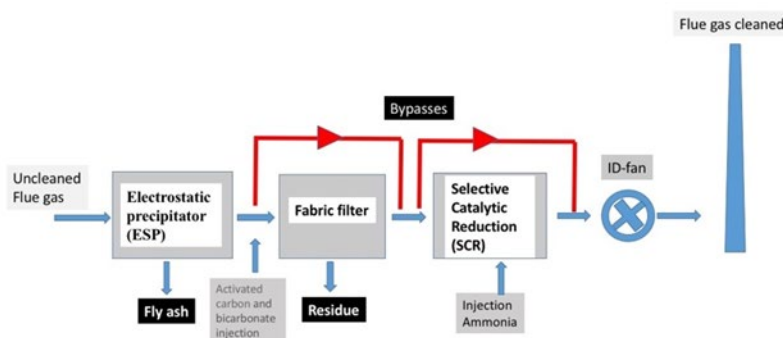
Figure 4: Block diagram flue gas cleaning REC Harlingen with bypasses

One of the reason why the REC incinerator exceeds the dioxins permit levels is the use of bypasses during transient phases, which means that the incinerator emits *without filtering* (Figure 4). In the technical literature this is known as a 'filter bypass mode', 'abatement bypass' or 'dump stacks'. The bypass mode is *structurally* programmed whenever elevated dust emissions occur. Although the plant management had recently promised to stop using bypasses, data don't confirm this has actually happened.

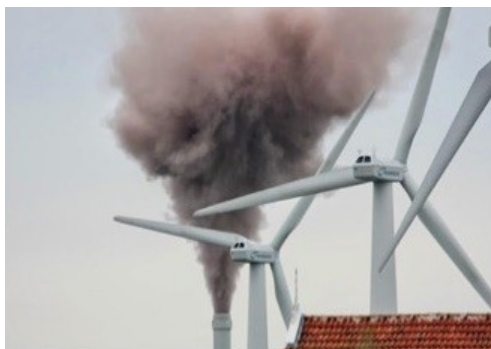
Figure 5: Emission of dust (dumpstack)

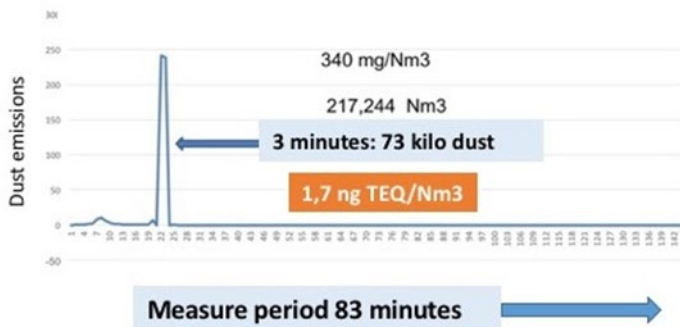
Figure 6: Dust emissions during phase 2 start-up REC Harlingen 2017

In Phase 2, no short-term measurements are possible, and dust can only be measured by gravimetric methods. Figure 6 shows how an indicative dust load of 73 kg was found in 83 minutes' measure-time, while the incinerator only declared 2 kg dust during this period. Figure 6 clearly shows that the dust emission lasts only 3 minutes. The dust meter of the incinerator is unable to

record excessive flows of dust in a short time. In Phase 1 the REC incinerator estimates the amount of dust emission to be 25-50 kg, but due the incapability of dust emissions meters (only 2% in Phase 2), the real quantity of dust emissions will be much higher. Dust emissions during start-ups without burning waste are structurally emitted without filtering. This has an economical reason: changing of filters, especially the bag or fabric filter is an expensive operation. Although emitting without filtering is prohibited, this practice occurs as a standard. As regards enforcement, penalising breaches is difficult, because emissions are only measured when waste is actually on the grate, and the bypassing system is still being applied (see Figure 5, which likely indicates emissions of dust saturated with dioxines and polycyclic aromatic hydrocarbon (PAHS)).
